Location
Gatekeepers Lodge, Windsor Great Park

Adamson Construction were contracted to repair a flat roof including the cracked and damaged leaded details.

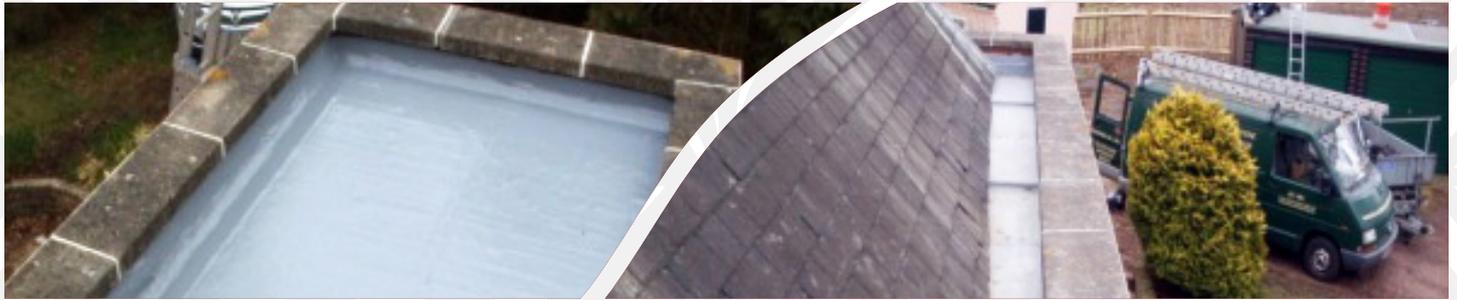
The flat roofing had deteriorated due to age and exposure to thermal movement and the lead lined gutters, lead bonnet details and ridge details were all cracked causing water ingress.

Flat Roofs, Ridge, Hips and Gutters; All debris and trailing Ariel leads were removed and the area was jet washed and cleaned with Belzona 9111 Biowash. The brickwork was pointed where required on inside of parapet. The render on the walls was hacked off and blown render replaced adjacent to the flat roof. The holes in the lead were then filled with Belzona E.S Stick. Bridging tape was then applied to lead / brickwork interfaces and a general surface conditioner to all painted surfaces. Finally 2 coats of winter grade Belzona 3131 were applied and fully reinforced with Belzona matting into first coat.

Porch Roof; The lead was raked out, jet/bio washed and Belzona TX Conditioner was applied before it was in-filled with high build resin and primed with GSC Conditioner. 2 coats of winter grade Belzona 3131 were then applied and fully reinforced with Belzona matting into first coat.

Coping Stones; The failed perpendicular joints were raked out to a depth of 10-12mm. Dust was removed and edge tapes applied before TX Conditioner applied. Finally, high build Belzona 4141 was applied to point the stones to blend in with the existing joints.
